Structure of the Åknes rock slope – comparable to other sites with drainage?

Workshop – Drainage of large rockslides - Oslo 30- 31th of January 2017

Jaboyedoff M. ¹ & Oppikofer T. ²

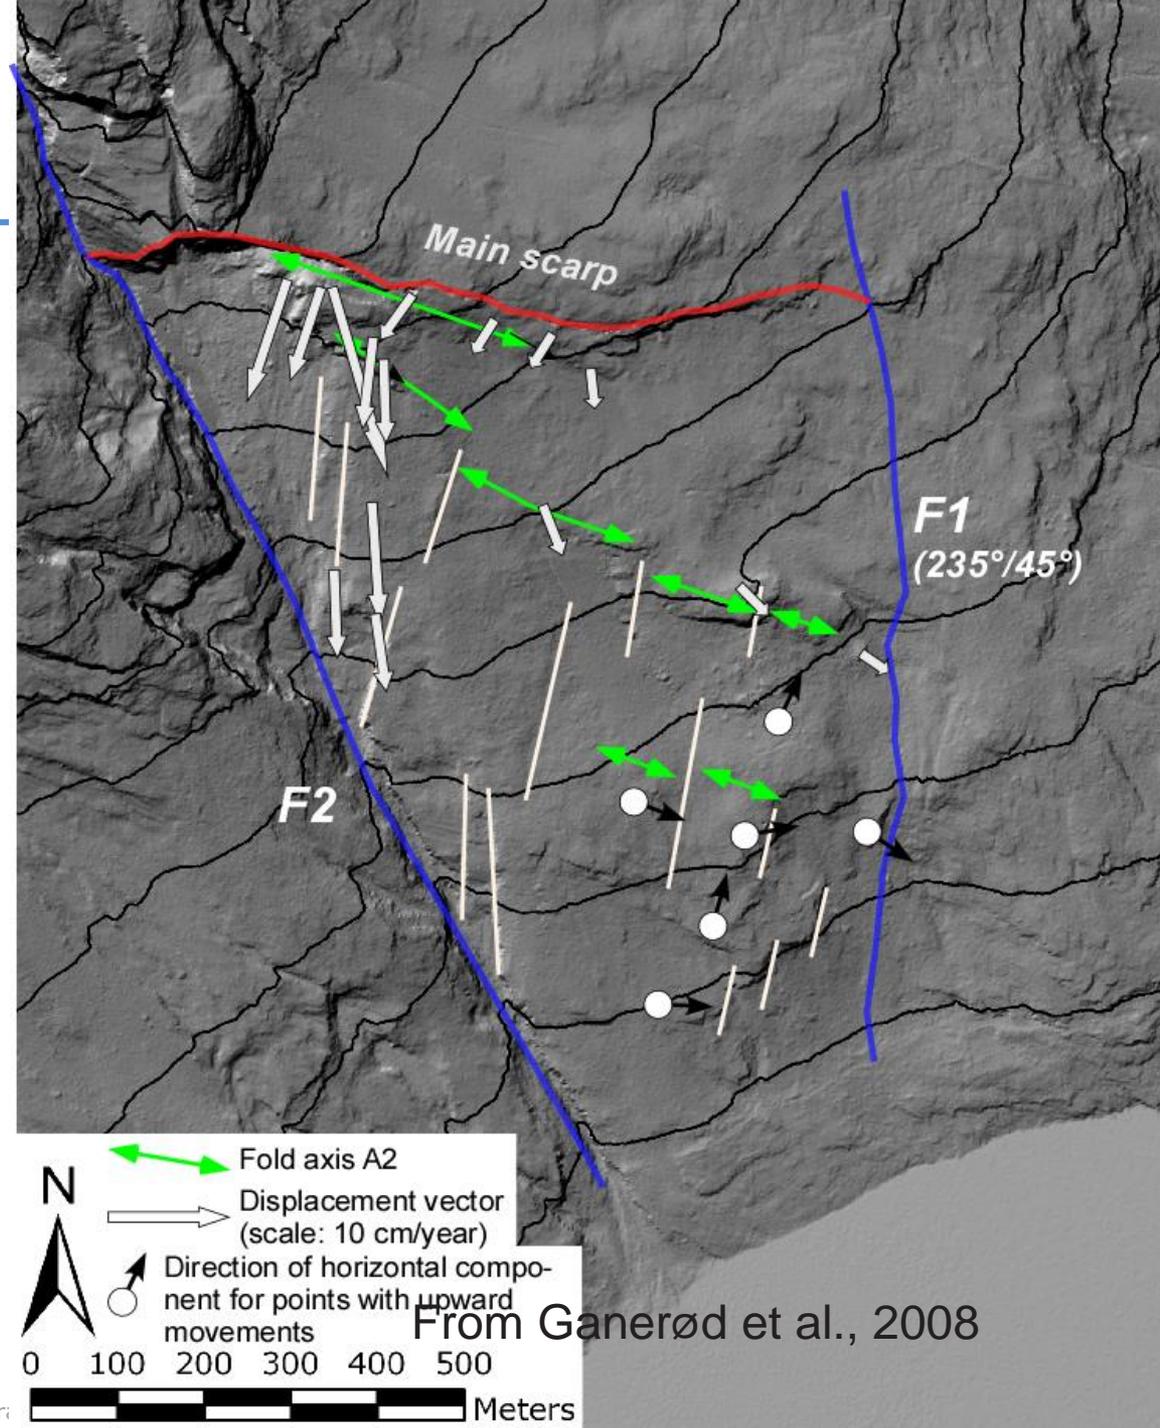
Displacements

• Hillshade model of the Åknes rockslide displaying the measured displacements (data from Blikra, 2008) and the main structural features. The two lateral faults (F1 and F2) are represented as blue line, the JNS joint set as white lines and fold axis A2 are shown in green.

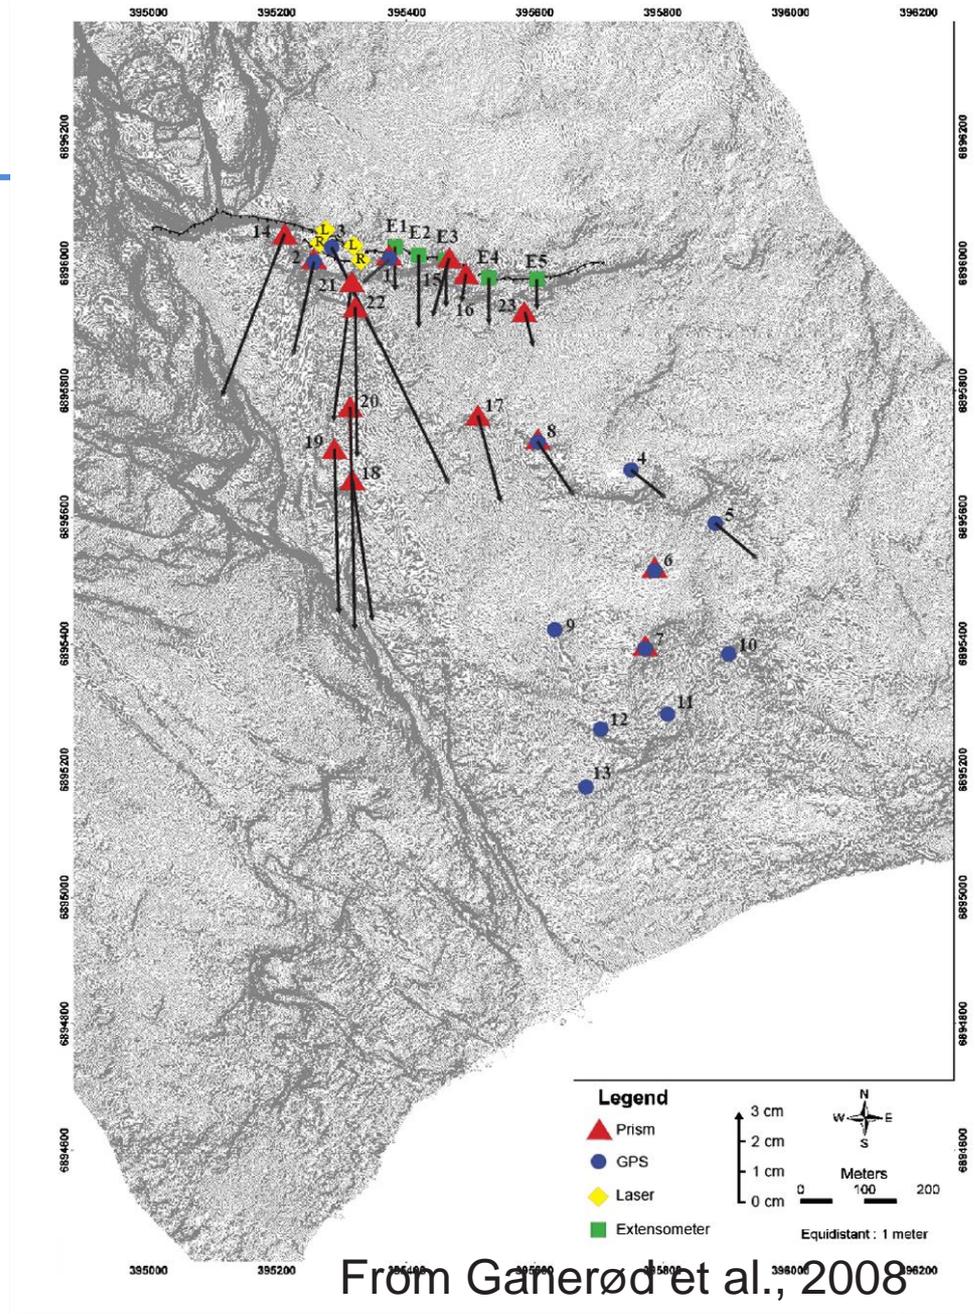
Displacements

• Hillshade model of the Åknes rockslide displaying the measured displacements (data from Blikra, 2008) and the main structural features. The two lateral faults (F1 and F2) are represented as blue line, the JNS joint set as white lines and fold axis A2 are shown in green.

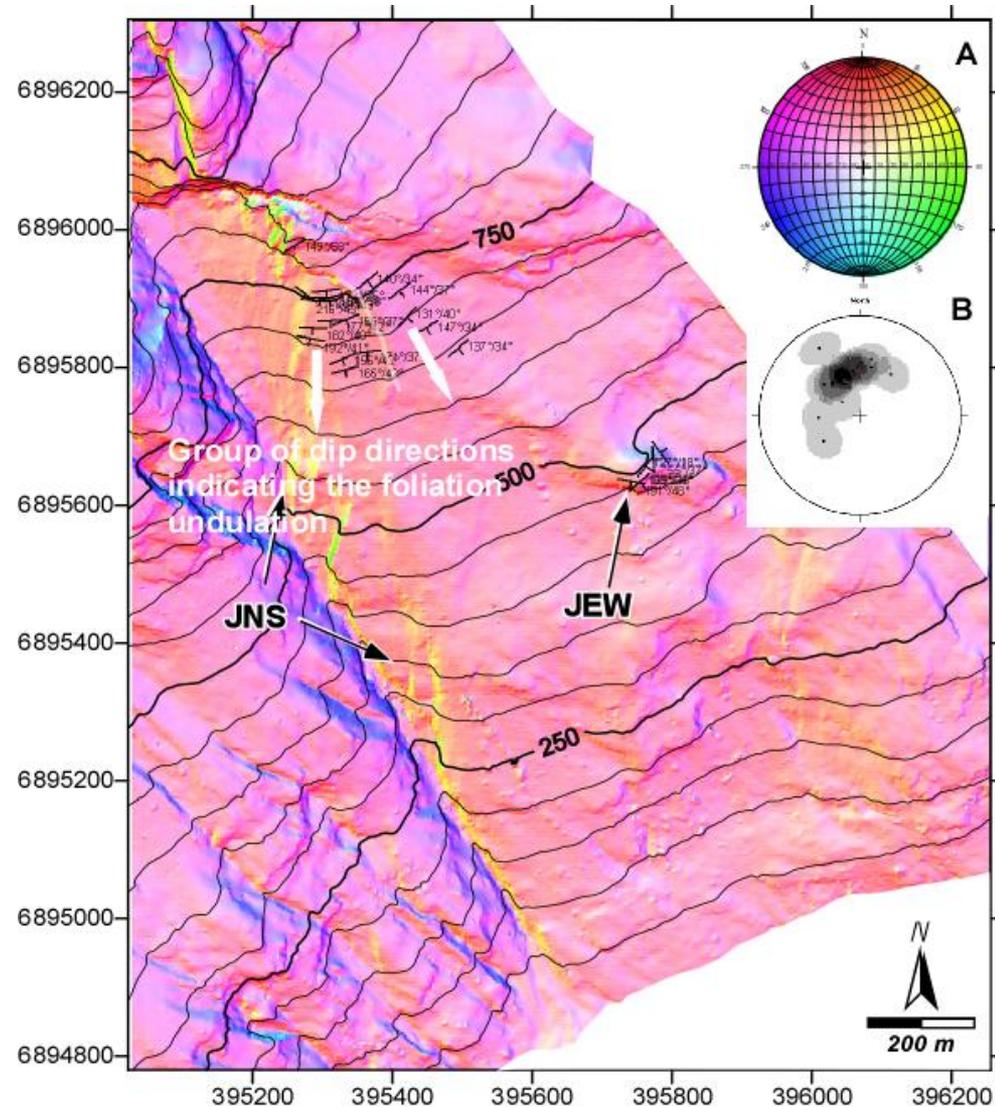
Surface structures

Orientation-specific colouring of the ALS-DEM in COLTOP showing the rapid variation of the foliation's orientation (white arrows). The slope orientations are displayed by a unique colour given by the pole in a lower hemisphere Schmidt stereonet in association with a Hue-Saturation-Intensity wheel (A).

The measurements on this COLTOP image were performed assuming that the slope follows the foliation, which is confirmed by field measurements. The poles of the measured foliation surfaces are shown in the density stereonet (B).

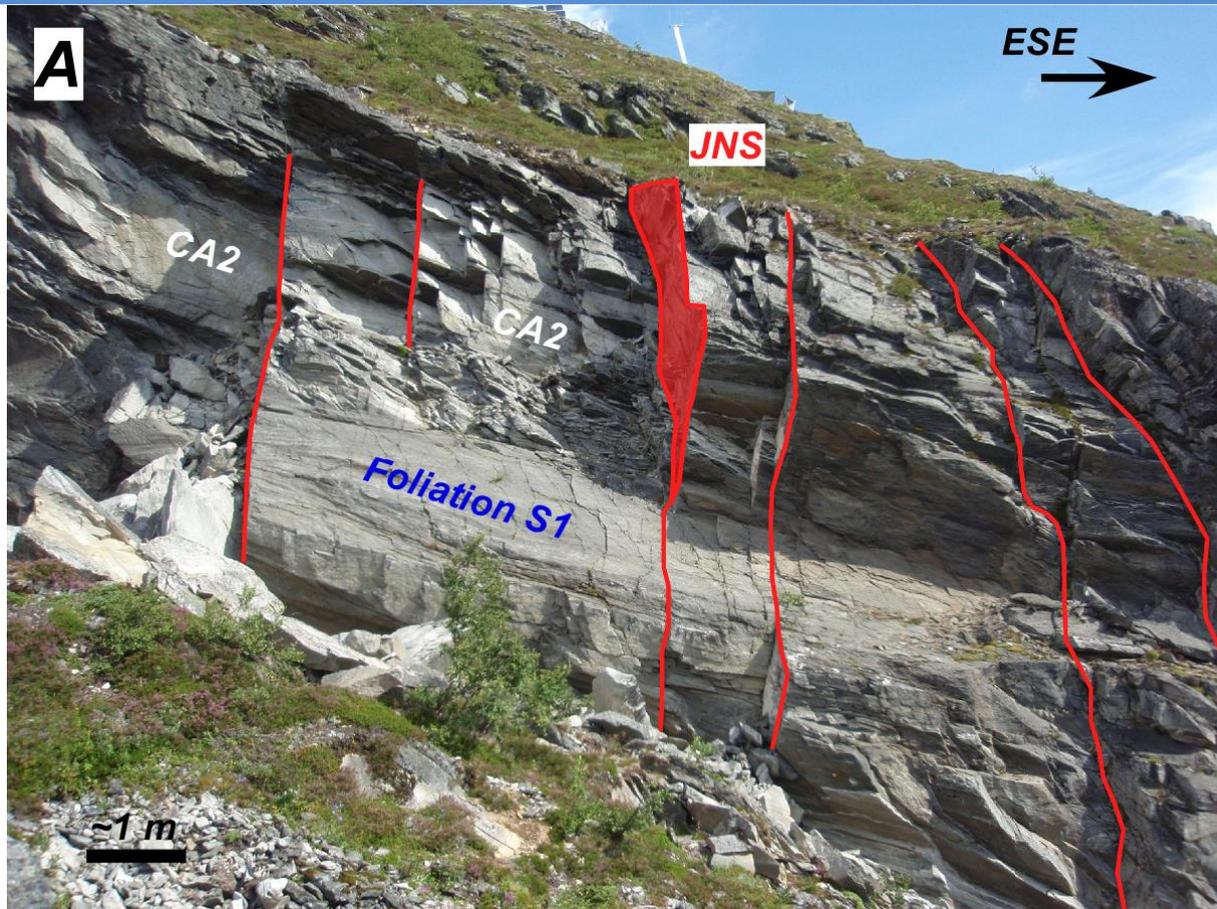
N-S system

(A) Outcrop in the main back-scarp showing the vertical foliation S1 folded within folds A2 and the cracks (CA2), the N-S-trending joints JNS are found everywhere and they cut quasi perpendicularly the folds. Note the variation in S1 orientation due to large-scale folding. North 10-20° are cutting the moving mass (also 175°)

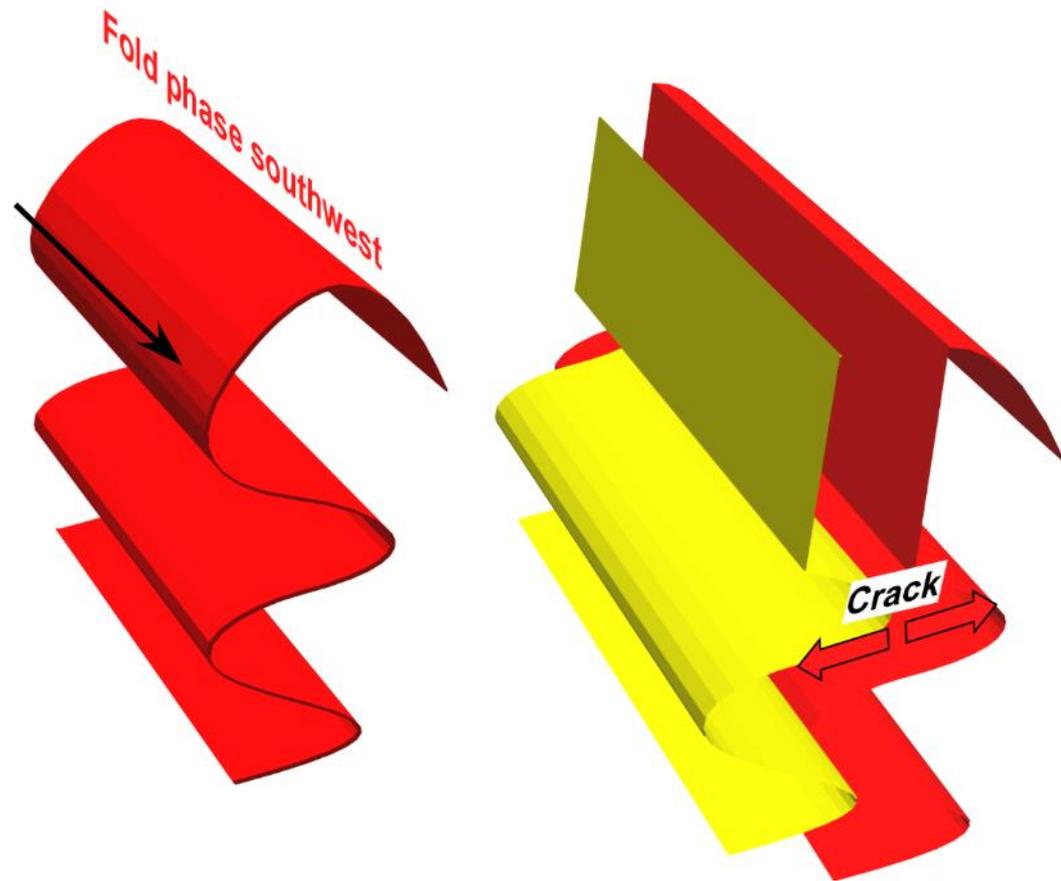
Failure along the fold

Scheme explaining how the weaknesses (cracks CA2) are induced by folds A2 in combination with folds A1. The cracks CA2 and the subvertical foliation S1 forms the backcracks of the Åknes rockslide and the former rockslide scars detected on the morphology of the slope.

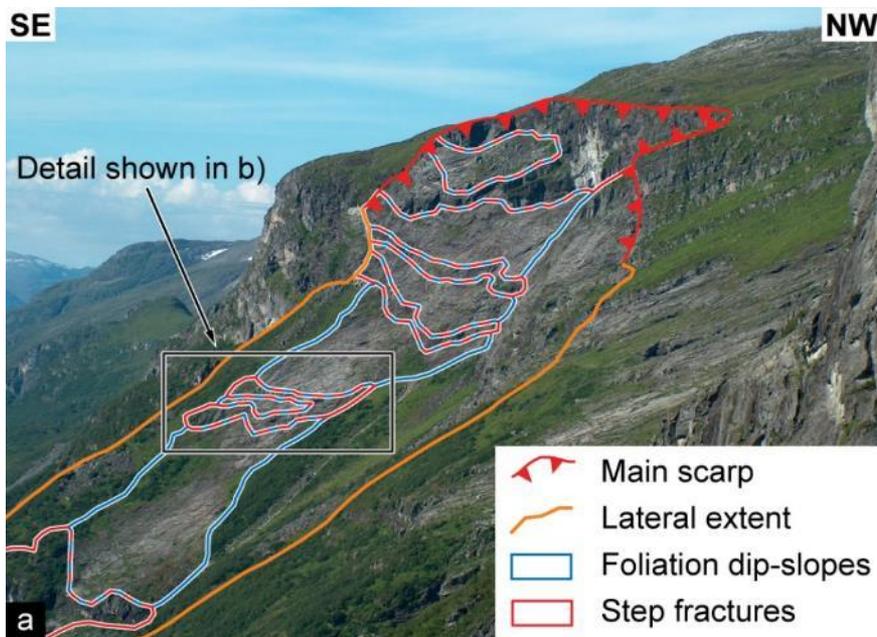
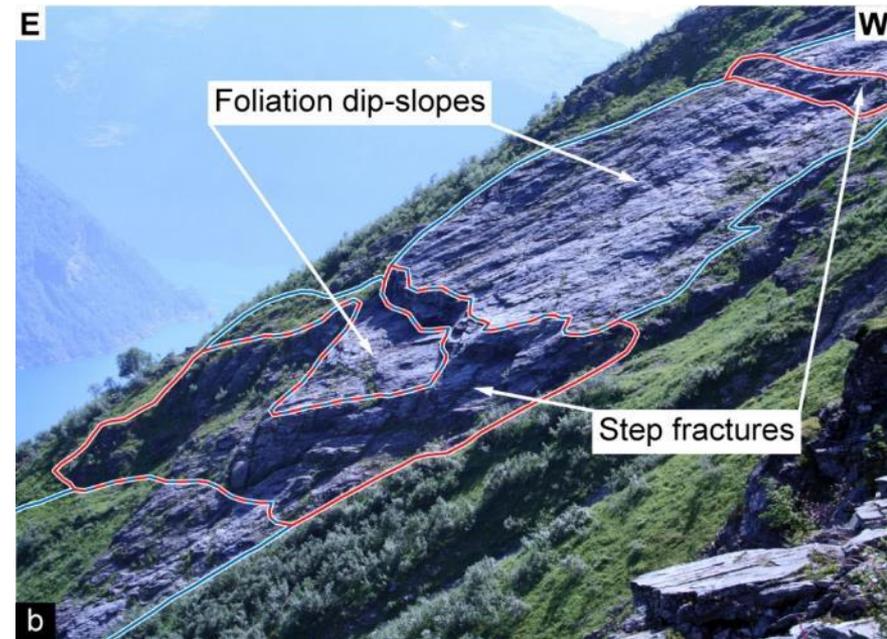
Sliding surface characterization

- Rockslide scar (6-8 Mm³; 10-11 ka BP)
- Stepped sliding surface formed by gneiss foliation dip-slopes and steeply dipping step fractures

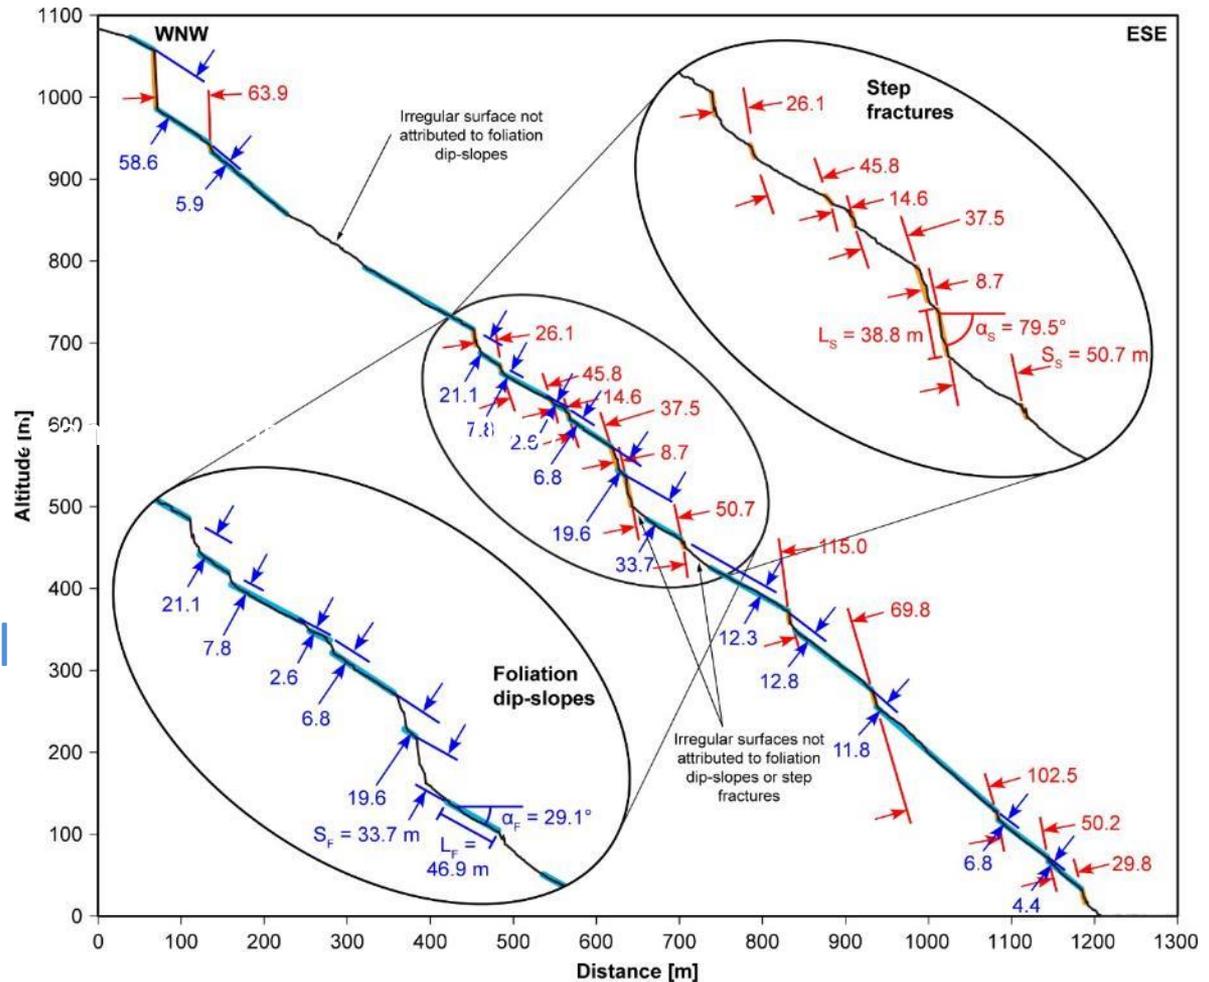
Sliding surface characterization

- Negative exponential distributions for trace lengths and spacings
- Normal distributions for dip angles
- Used for stochastic simulations of basal sliding surfaces

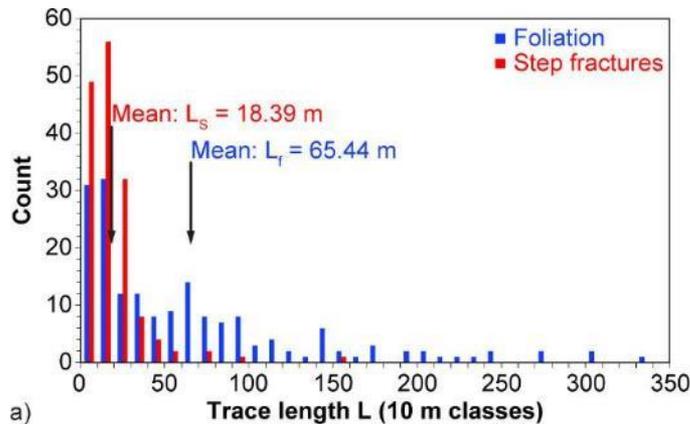
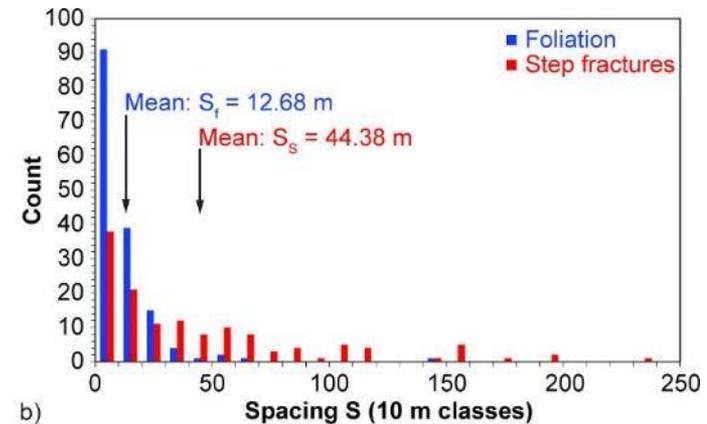
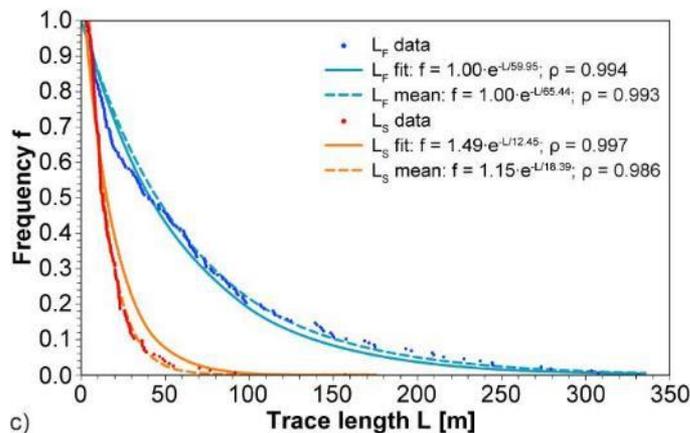
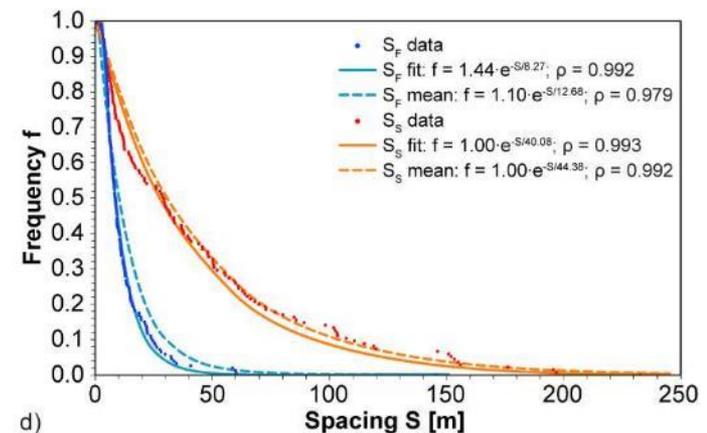
- Spacing and trace lengths show exponential negative distributions (from Oppikofer et al., 2008)

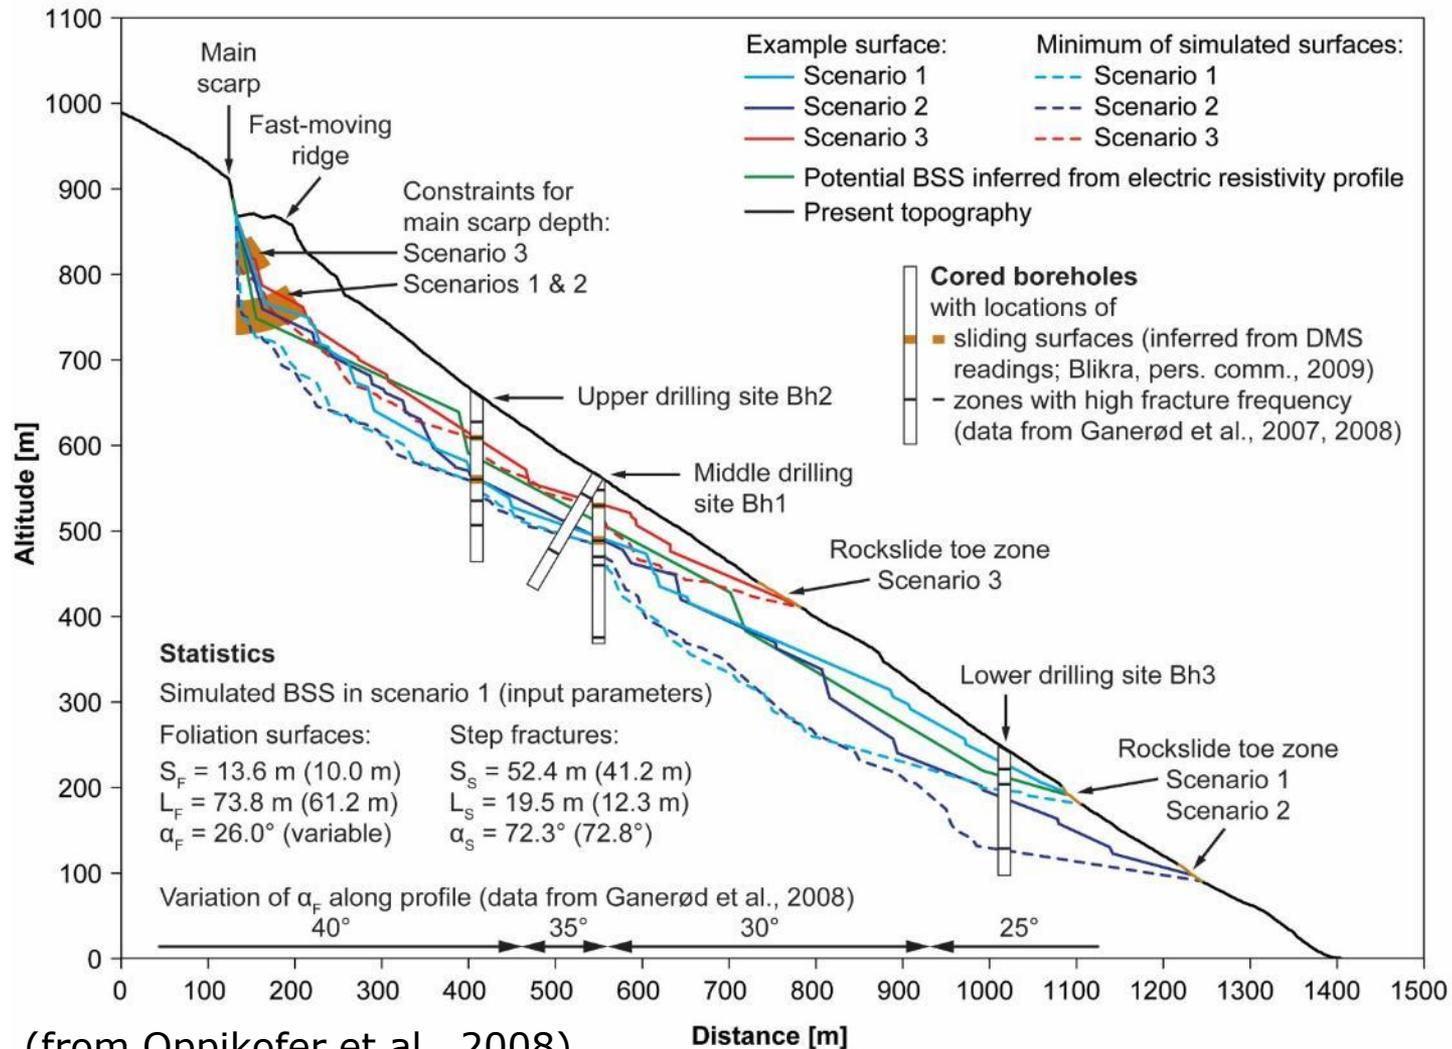
Stepped sliding surface at Åknes using fracture simulations

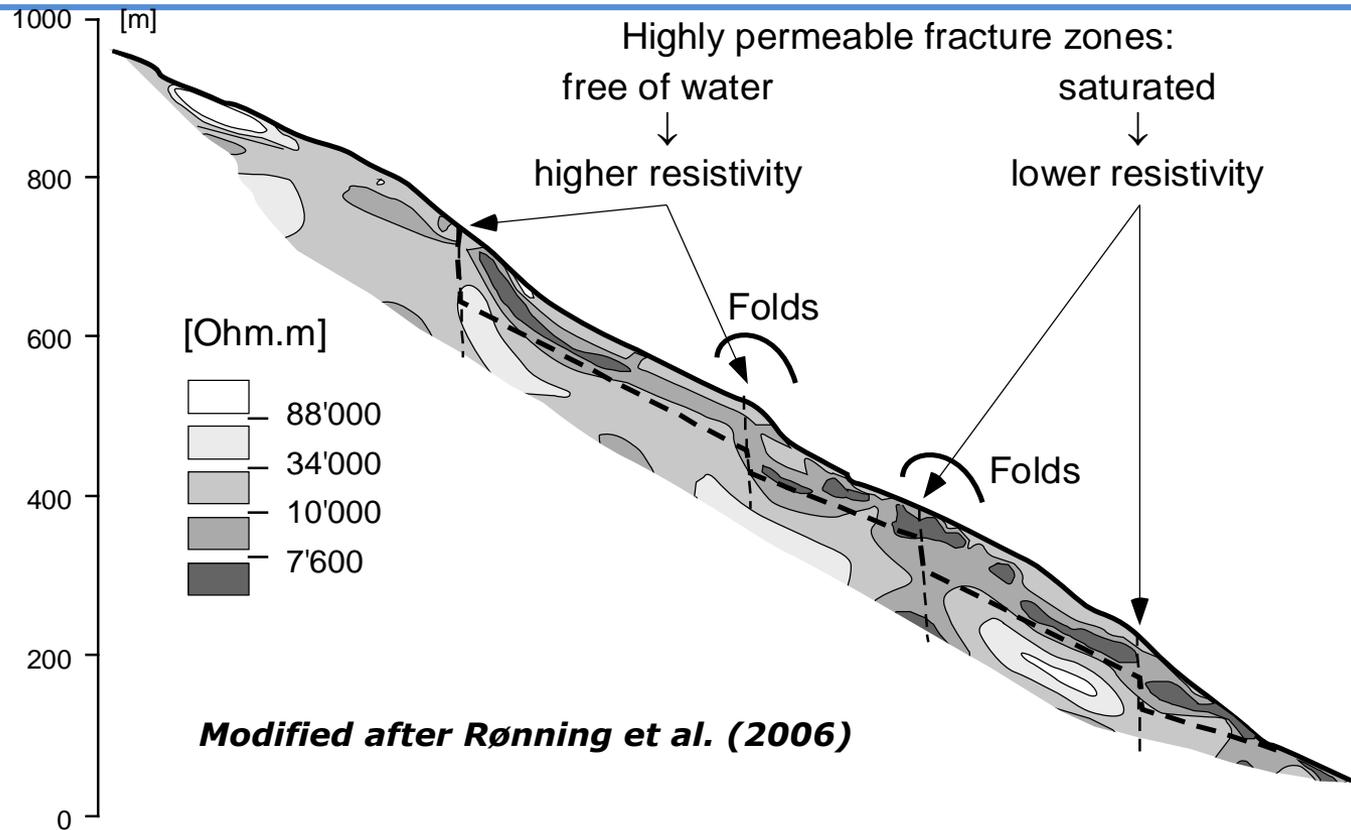
Interpretation of electrical profiles

- Interpretation of the stepped failure surface (dashed black line) based on an inversion of a longitudinal 2D electrical profile (electrical profile modified after Blikra et al., 2006). The vertical dashed lines indicate the vertical fractures linked to weaknesses (CA2) created by folds or to the JEW joint sets. It is assumed that they are creating highly permeable zones that are either saturated or free of water and therefore giving opposite electrical responses.

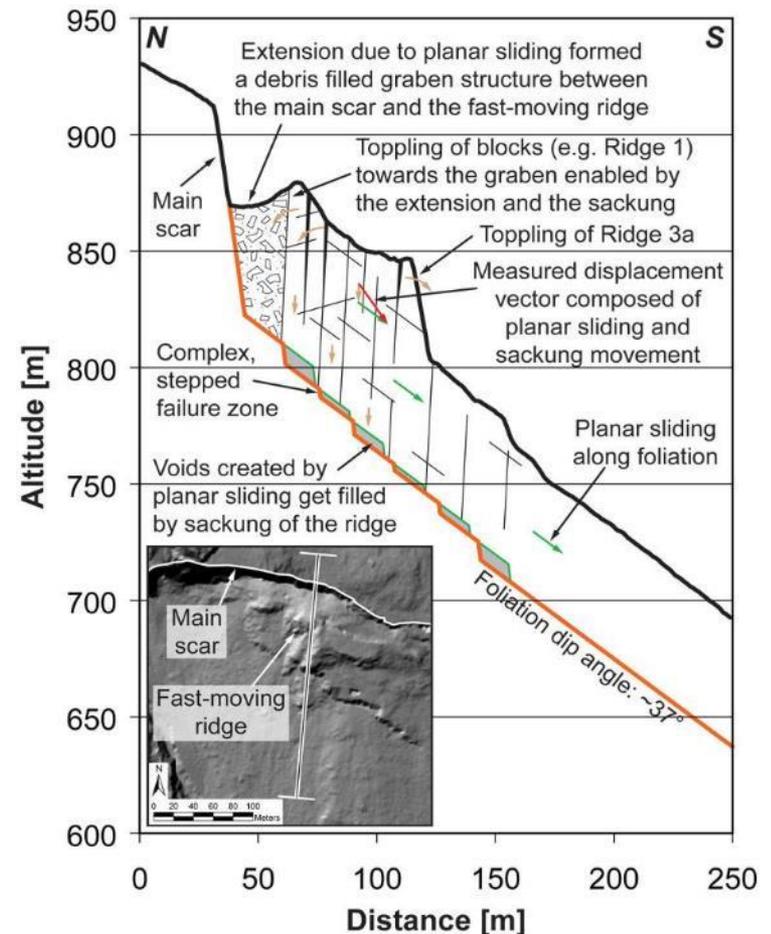
Rockslide mechanism – upper part

- Translational sliding parallel to the foliation planes
- Complex stepped basal failure surface creates higher downward displacements of the ridge
- Extension creates rear-bounding graben structure → filled by debris, enables back rotational toppling of the ridge

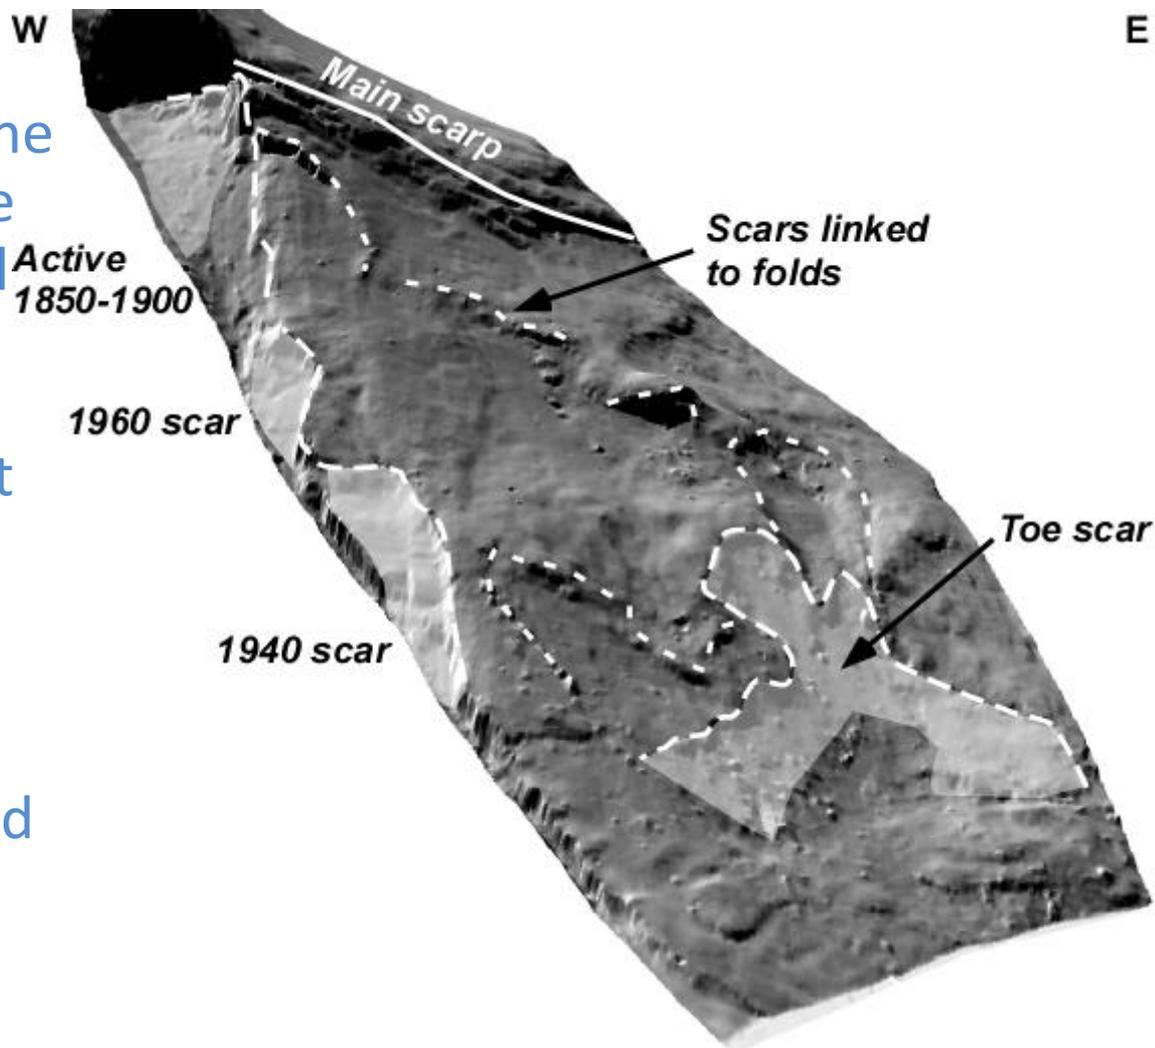
Some of the apparent old scars, part of them are still active

3D representation of the hillshade indicating the former scars. Historical rockslide activity was located at the western boundary (next to fault F2), like the 1940 and 1960 scars. More ancient scars can be detected in the rockslide's toe zone and in the middle eastern part.

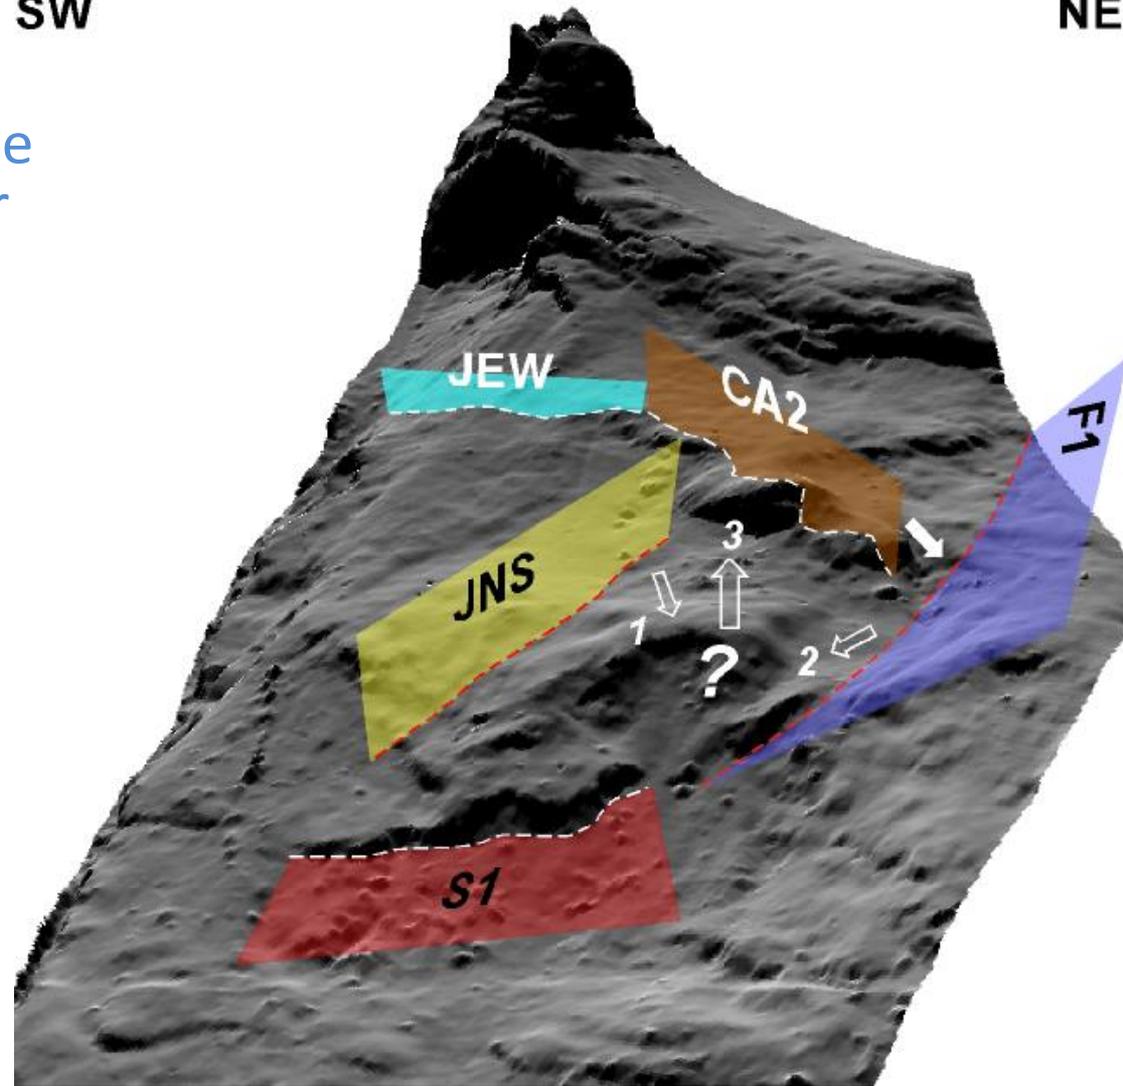
Summary

Possible interpretation explaining the potential upward movements at the toe. (1) The middle upper part of the rockslide moves down to the SSE along S1 and (2) the eastern part slides down to west along F1.

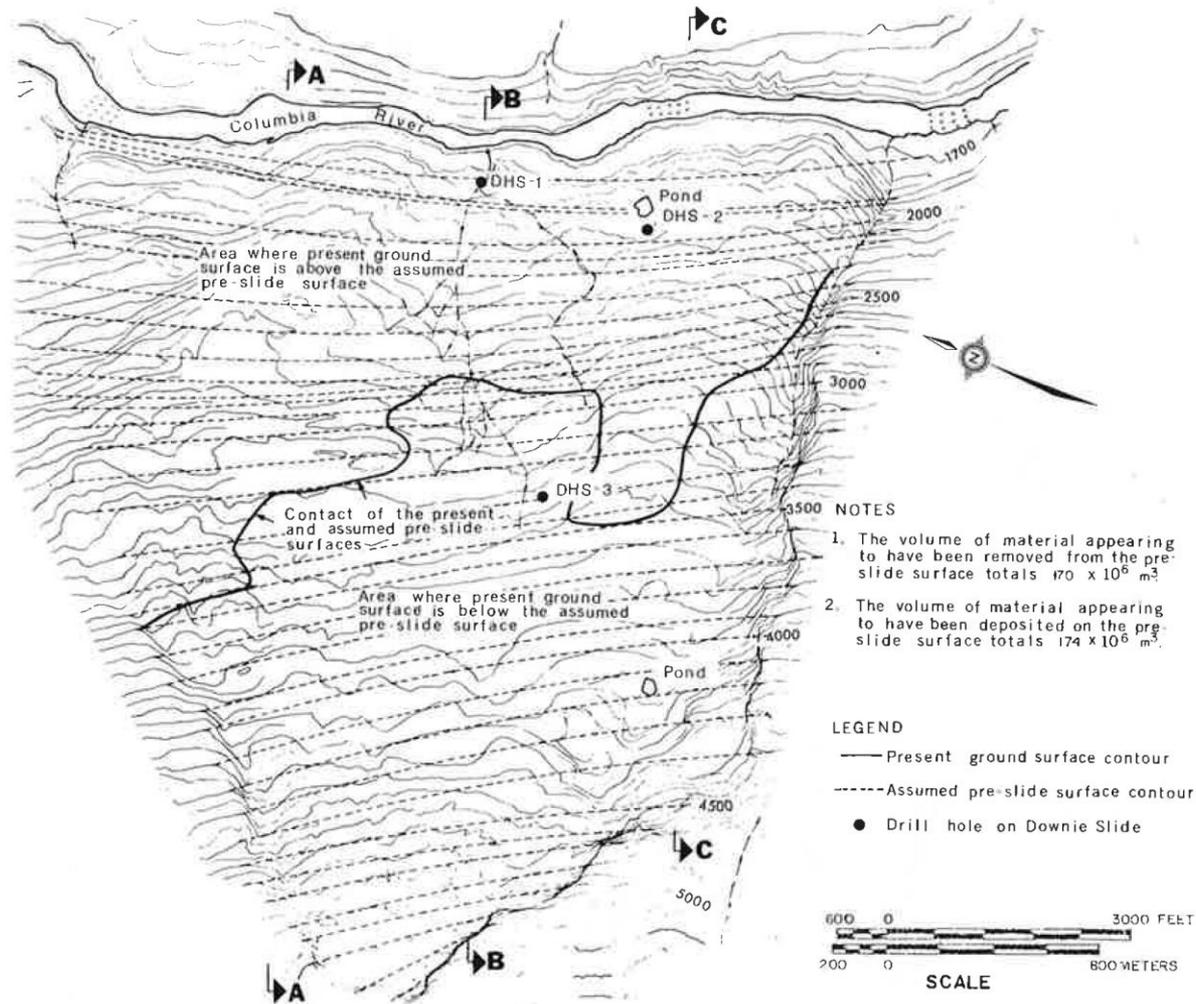
Fig. 19. Plan of the Downie slide showing the contact between the present ground surface and the estimated pre-slide ground surface. Contours are in feet.

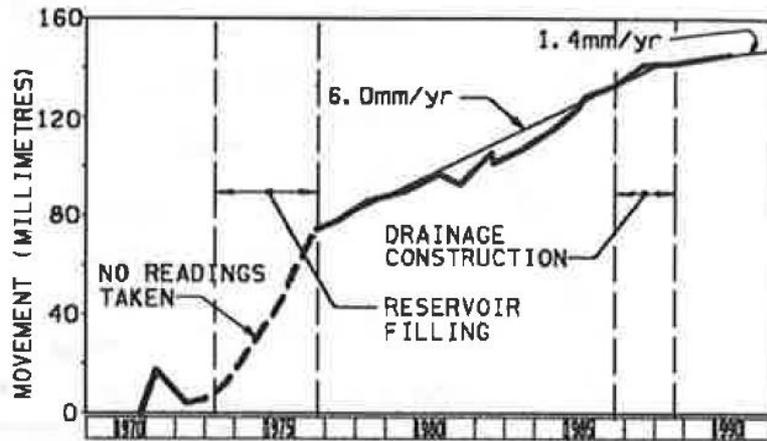
Fig. 1 - Rate of Movement on the Basal Fault

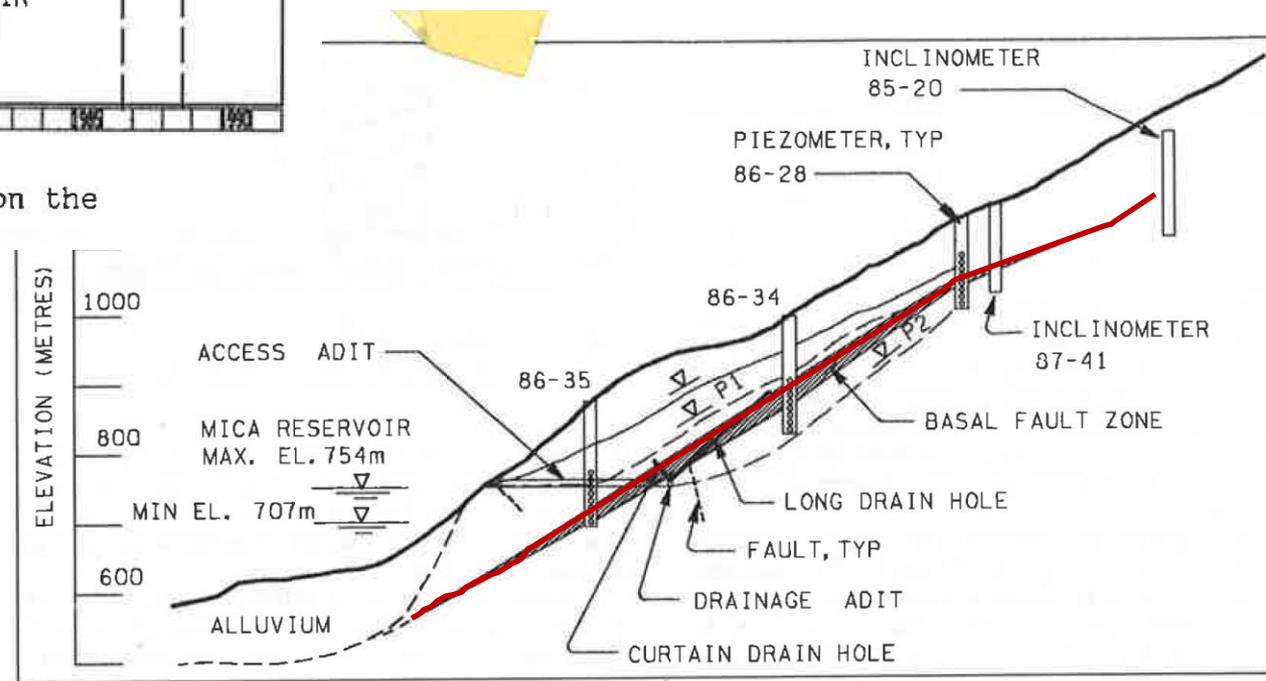
Fig. 3 - Cross section. Water levels before drainage and after drainage below (P2) and above (P1) the Basal Fault

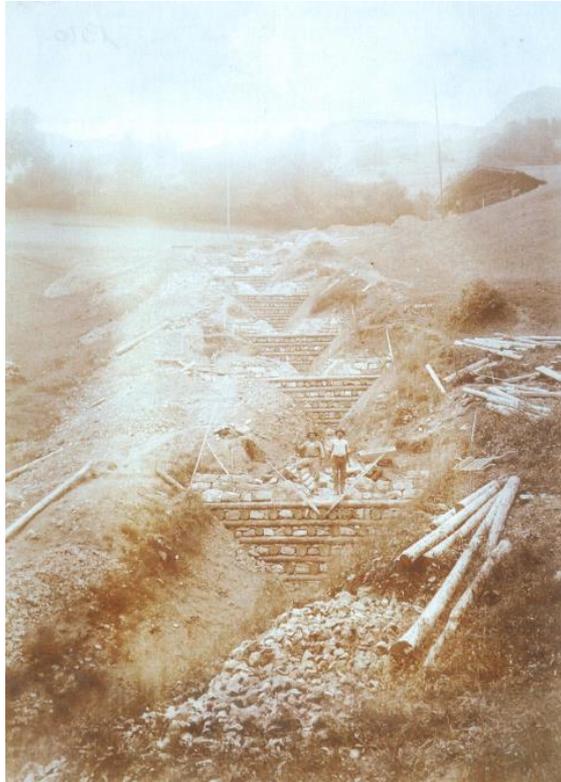
- (Left) Works to clean the slip of La Frasse, circa 1910 (picture from the Ormonts museum). (Right) Drawing of the drainage gallery with follow-up of the BEG company (from www.vd.ch/fileadmin/user_upload/themes/environnement/eau/fichiers_pdf/Frasse_POSTER5_AO_Geologie_page1.pdf)

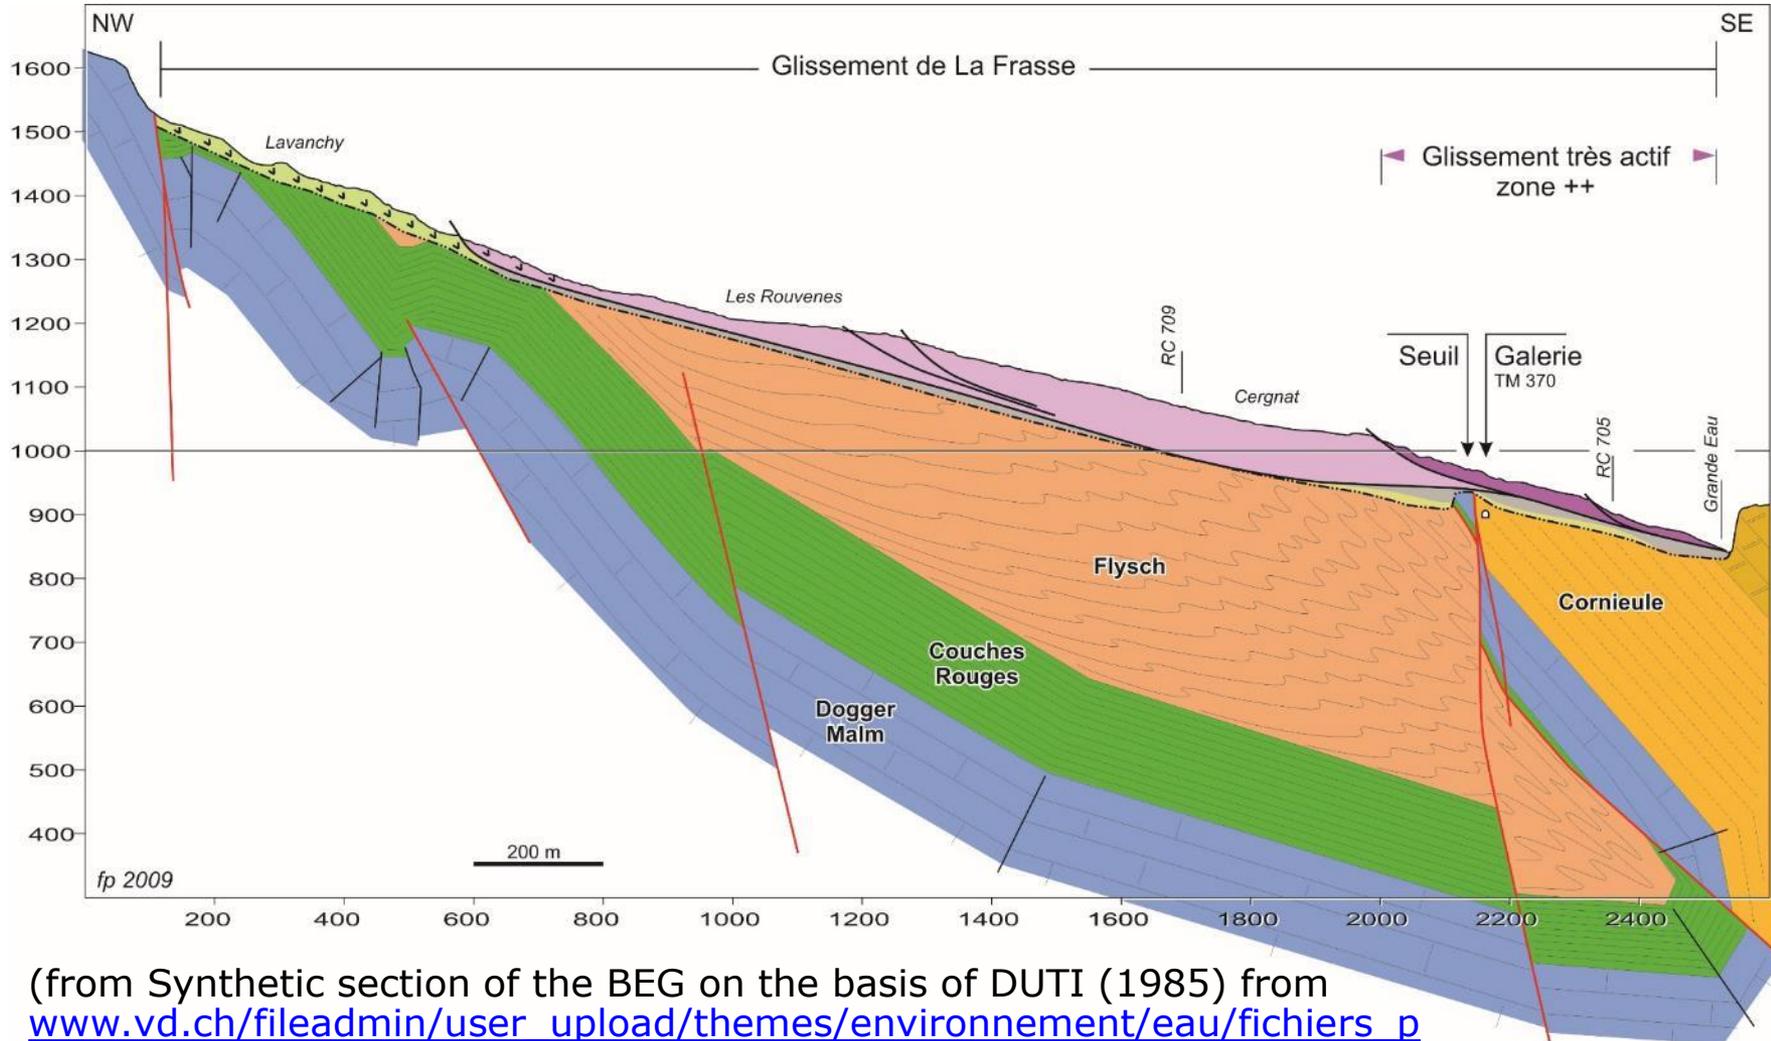
Cross-section

(from Synthetic section of the BEG on the basis of DUTI (1985) from www.vd.ch/fileadmin/user_upload/themes/environnement/eau/fichiers_pdf/Frasse_POSTER5_AO_Geolgie_page1.pdf)

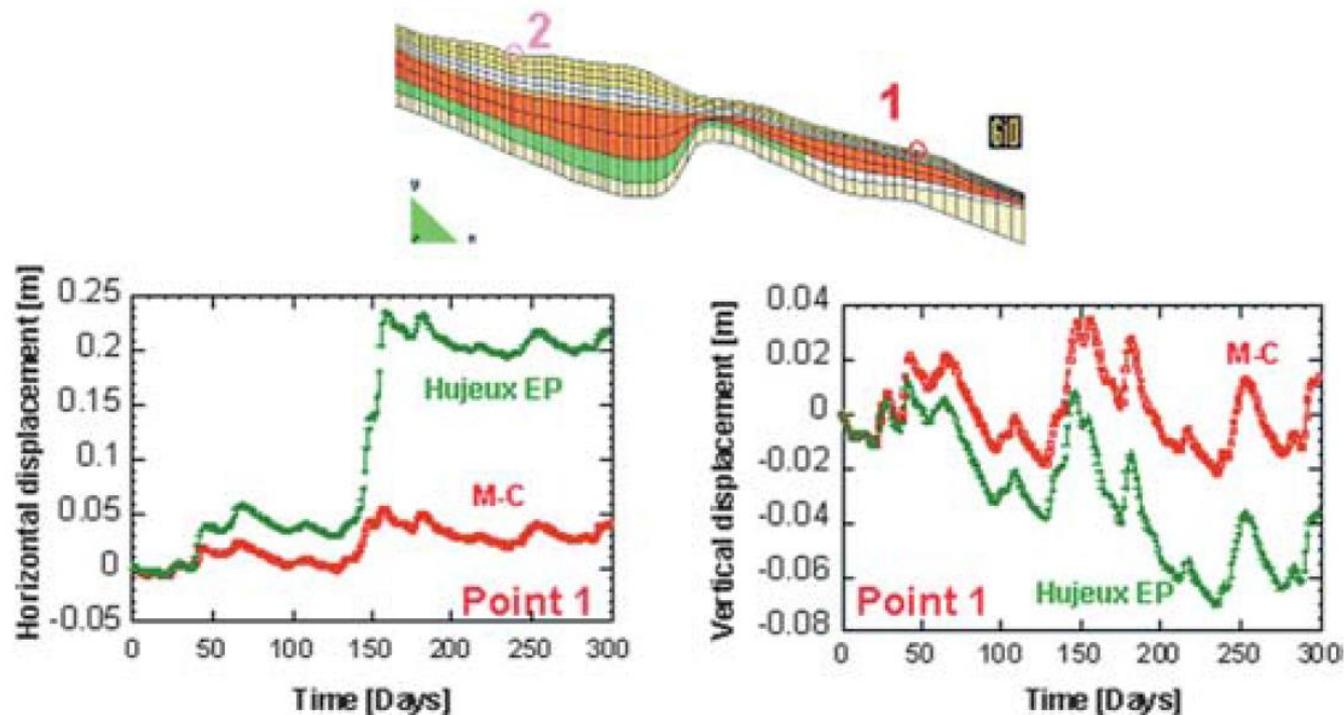
Fig. 20 Numerical simulation of the landslide displacements using two constitutive models for the slide layer: Hujeux elasto-plastic and Mohr-Coulomb (M-C) constitutive models
