# Hydrogeological Conditions at Åknes in a larger Alpine Framework

Simon Loew  
Christian Frei  
Reto Thoeny

# Roadmap

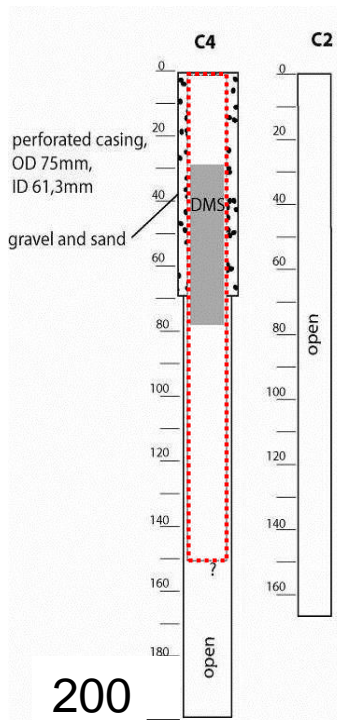
# Borehole Characteristics

**Upper drilling site**  
(658 m asl)

**Middle drilling site**  
(565 m asl)

**Unsaturated**  
200

**Lower drilling site**  
(236 m asl)

- The observed unsaturated zone at 190 m depth at the middle drilling site suggests a hydrogeologic stratification with a perched near surface aquifer feeding the middle spring horizon and a main aquifer feeding the lower spring horizon

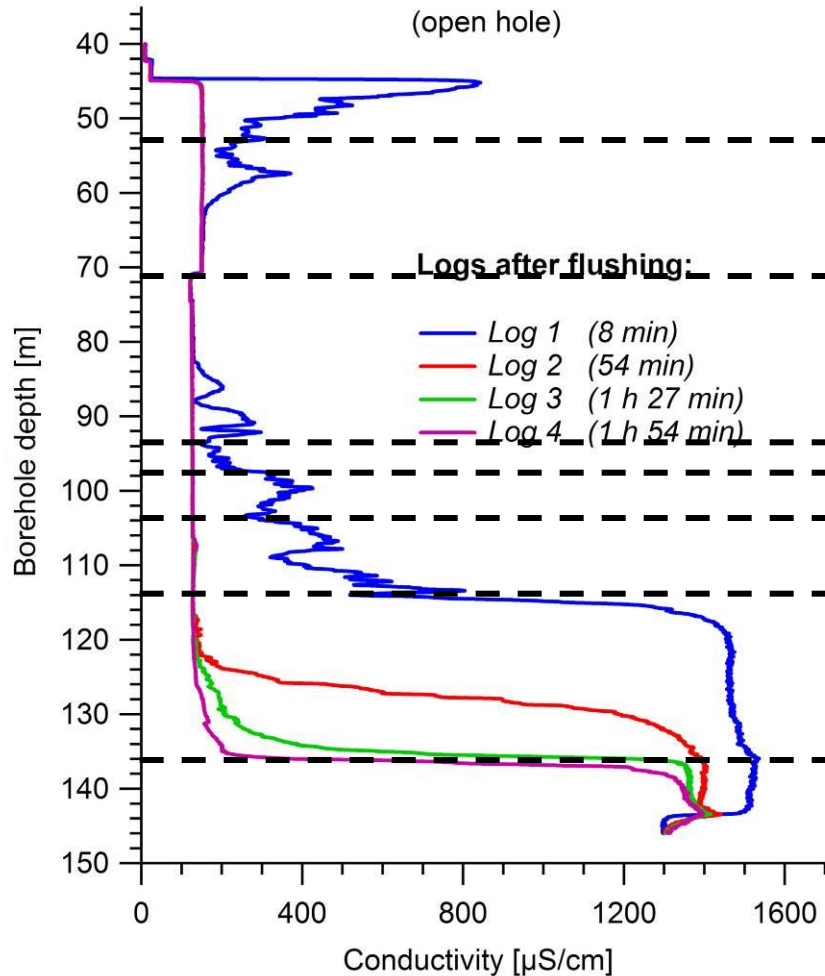
Borehole C3  
(open hole)

# Comparison of Cased & Open Boreholes

$T \sim 1E-2 \text{ m}^2\text{s!}$

- We observe a very transmissive & unsaturated layer in the uppermost 40-50 m bgs (transmissivity  $> 1E-2 \text{ m}^2/\text{s}$ ) corresponding to the heavily fractured part of landslide mass

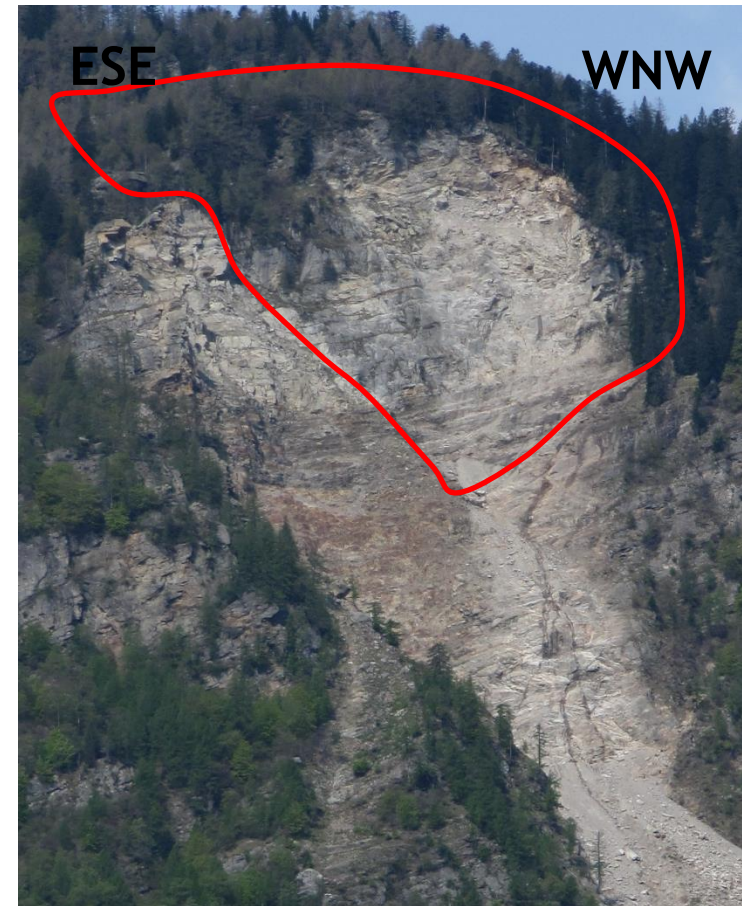
# Rock Slope Instability above Preonzo (Before Failure of May 2012)

Vertical View

Horizontal View
